Technical Evaluation of the Gold King Mine Incident

San Juan County, Colorado

U.S. Department of the Interior
Bureau of Reclamation
Technical Service Center
Denver, Colorado

October 2015

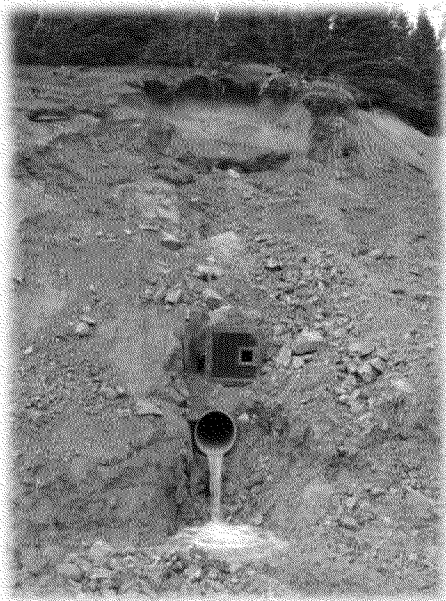
Gold King Level 7 Old Portal Closure

Both Level Seven portals were partially collapsed prior to backfilling in 2009. The Level Seven New Portal required additional fill to remove the unstable fifteen feet of continually collapsing timbered area that remained in front of the complete portal collapse from fifteen feet on. The Level Seven Old Portal also required additional closure in front of the complete portal collapse from thirty feet on. An observation pipe and drainage pipe were placed in the Level Seven Old Portal, but during filling around the pipes, the timbers in the portal collapsed and loose colluvial material completely covered the observation and drainage pipes. The drainage pipe continues to drain at roughly 200 gallons per minute, at the same flow rate as before the collapse. The observation pipe was meant to provide stable access to view the collapse at thirty feet, allowing the landowner and the DRMS to monitor this unstable draining adit, which is arguably one of the worst high quantity, poor water quality draining mines in the State of Colorado. Because of the collapse, DRMS decided to install a well point, driven into the collapse, through the drainage pipe, in an attempt to alleviate concerns about an unstable increase in mine pool head within the Gold King workings. The installed 6 inch perforated steel pipe penetrated approximately 12 feet of collapsed material thought to exist between the original collapse and the end of the drain pipe. The well point was unable to penetrate through any of the original existing collapse in the tunnel.

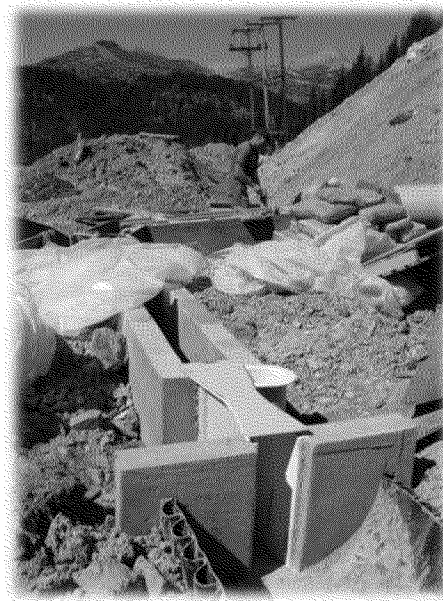
Gold King Level 7 Old Portal with 2" Parshall Flume Installed in Concrete Lined Ditch

A flume was installed at the Level Seven Old Portal as part of the bond revocation reclamation. The two inch Parshall Flume was installed in a concrete lined ditch immediately in front of the HDPE lined ditch. The flume will be used to monitor flow by the landowner and the Animas River Stakeholders Group (ARSG).

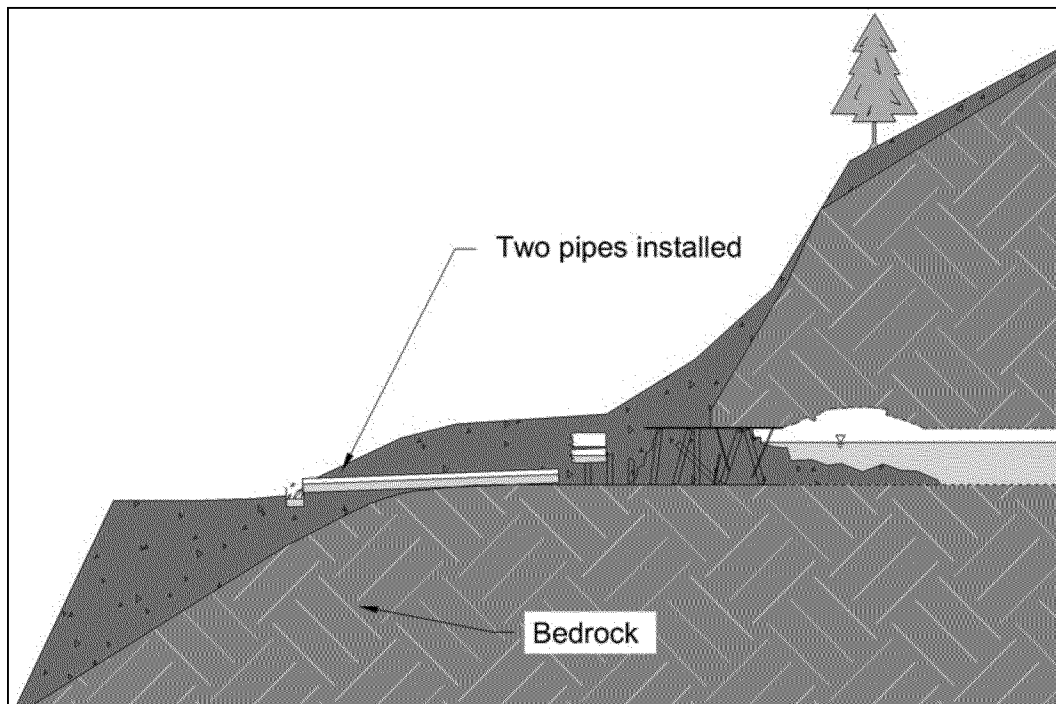
Figure 30.—Cross-section showing the condition of the Gold King Mine Level 7 New Adit in 2014 (water level as assumed by EPA and DRMS), after the installation of the two drain pipes and backfill cover (not to scale).

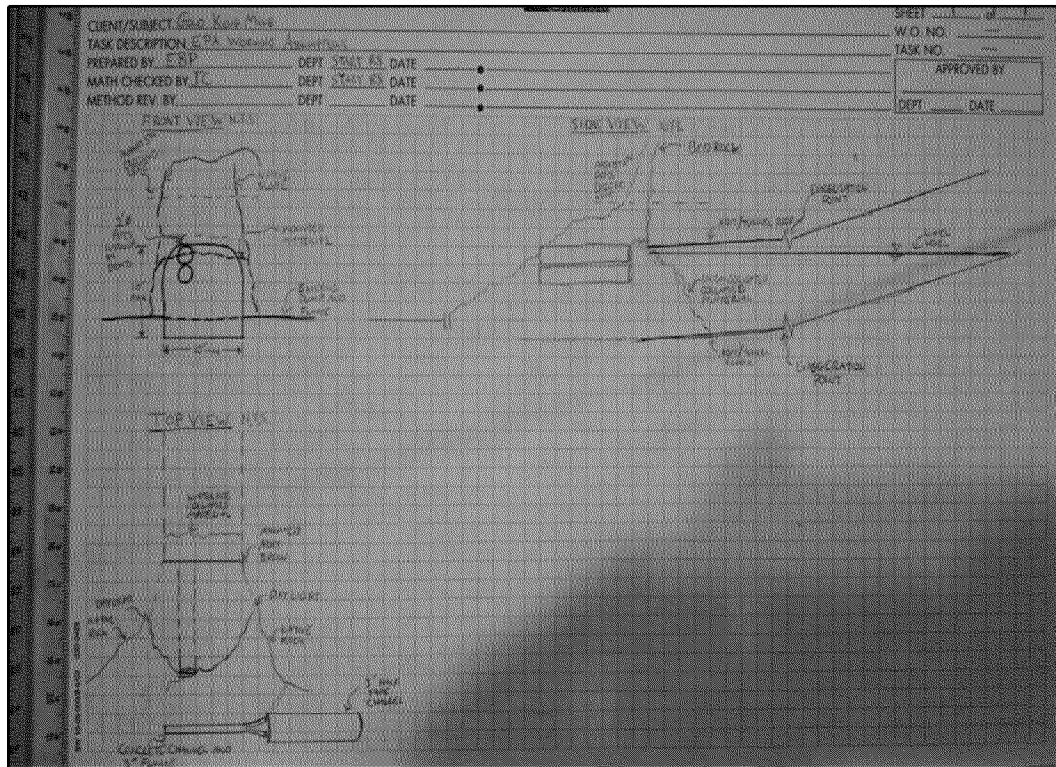
Figure 39 shows a sketch of the plan to open the Gold King Mine Level 7 New Adit portal. To provide a margin of safety, the plan assumes the water was more than 5 feet deep on the upstream side of the blockage, but still below the adit roof.

Figure 39.—Photograph showing the sketch used by EPA to illustrate the conditions at the Gold King Mine Level 7 New Adit portal (photograph from EPA project files).

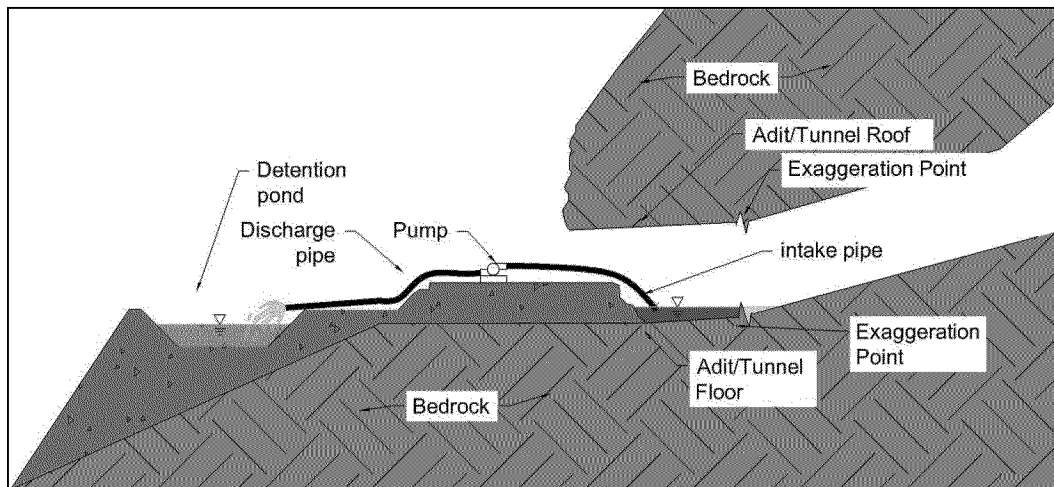
Figure 45.—Cross-section illustration showing step 5 of the plan (not to scale). As the water inside the mine is drawn down by pumping, additional fill from the blockage is excavated and the pump is repositioned to a lower level on the remaining fill. This step is repeated until all the impounded water and the remaining fill is removed; this will establish access to an open adit with the flow freely draining out.

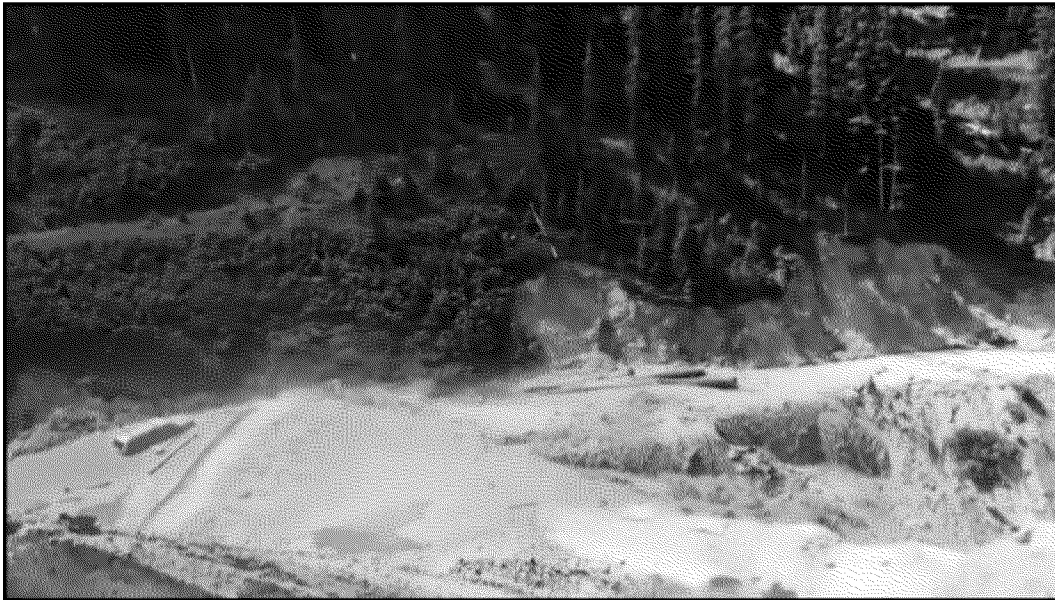
Figure 56.—Photograph showing at left, the inundation of a vehicle parked near the base of the waste-rock dump, and on the right water overwhelming the access road and cascading down into the North Fork of Cement Creek (still frame extracted from a video taken on August 5, 2015, at approximately 10:57 a.m.).

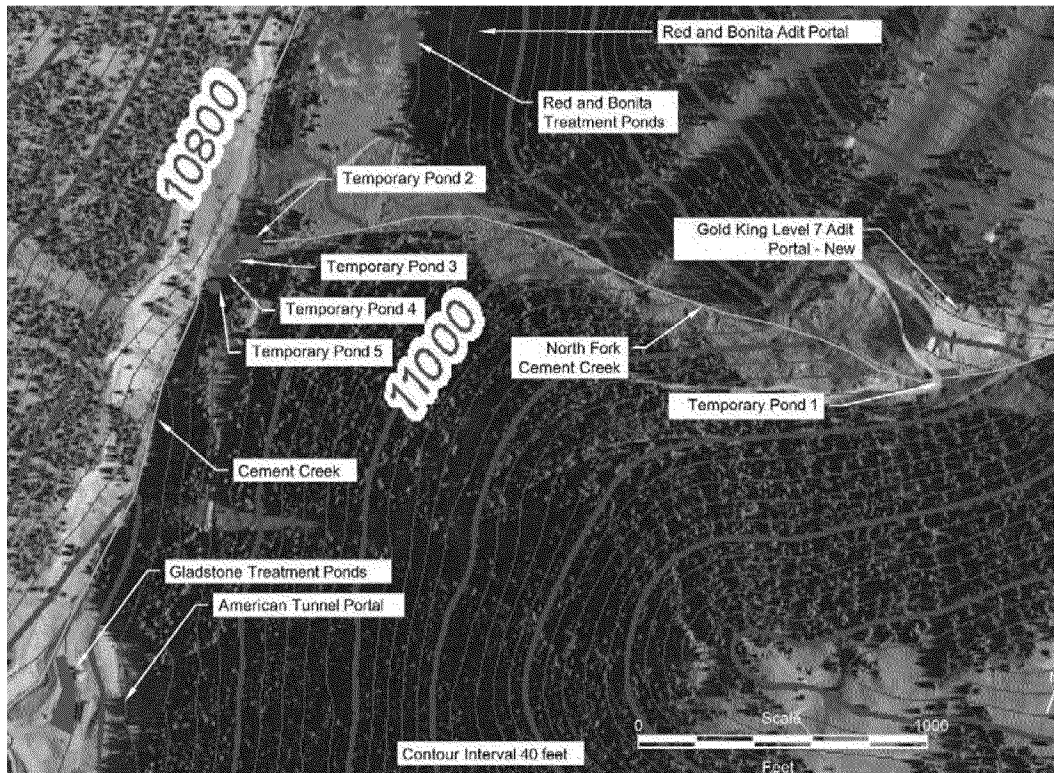
Figure 61.—Illustration showing the location of the temporary treatment ponds that were placed on the North Fork of Cement Creek after the incident.

After notifications were initiated, work began on road repair to reestablish access to the site. This work continued into mid-September. Most of the debris had been deposited in Cement Creek near the confluence with the North Fork of Cement Creek. The debris was removed. Temporary water treatment ponds were constructed on the North Fork using the debris (figure 61). The ponds were immediately put into operation.

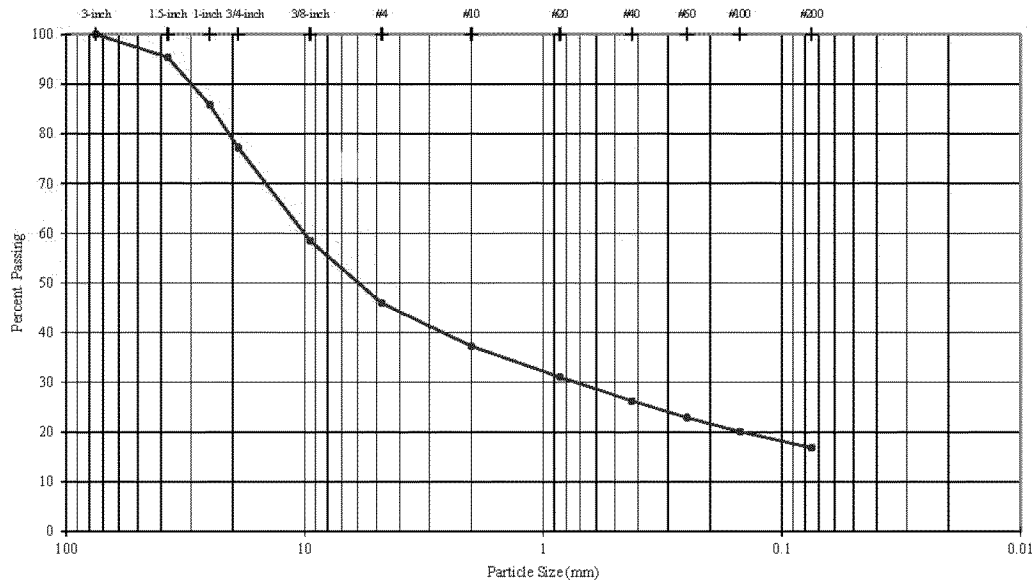
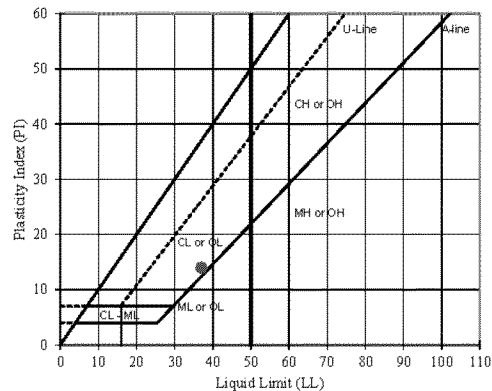
PROJECT NAME: USBR/Lab Testing - 2014/CO
SAMPLE ID: #1
TYPE: Pail

Visual Description:
Clayey gravel with sand, yellowish brown, moist

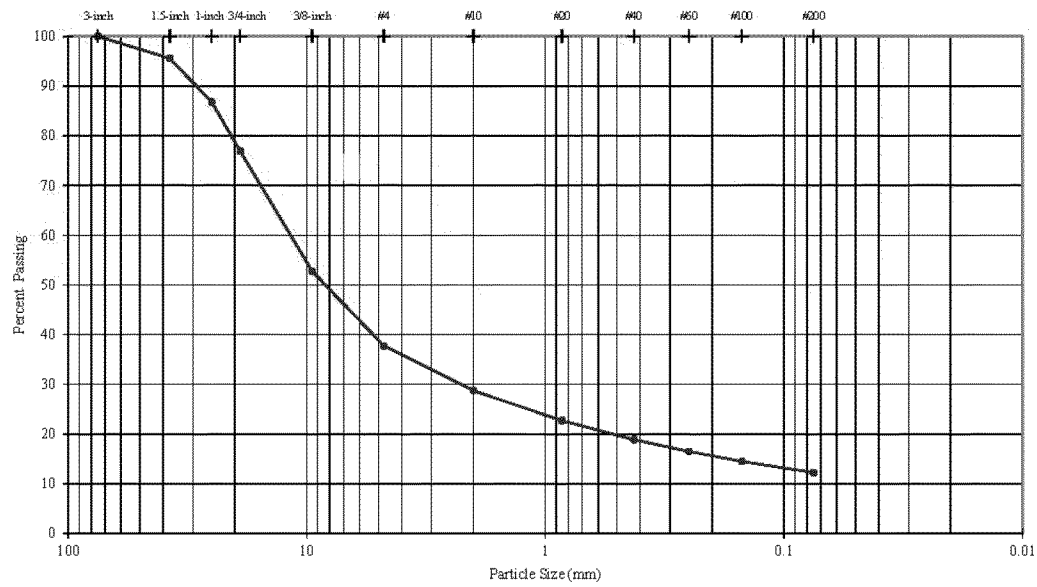
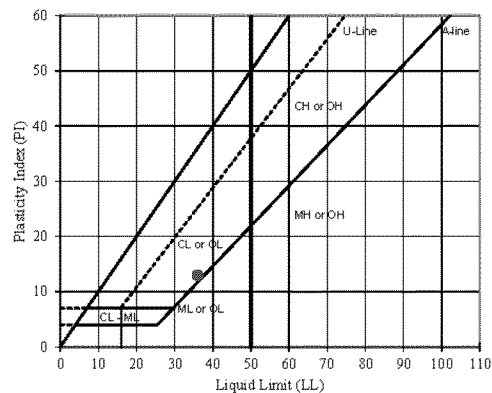
PROJECT NAME: USBR/Lab Testing - 2014/CO
SAMPLE ID: #2
TYPE: Pail

Visual Description:
Clayey gravel with sand, yellowish brown, moist

LL	PL	PI
36	23	13
